**Acoustics'08
Paris**
June 29-July 4, 2008
www.acoustics08-paris.org

Noise and vibrations at tram track intersection

Stjepan Lakusic^a, Marijan Bogut^b and Visnja Tkalcevic Lakusic^a

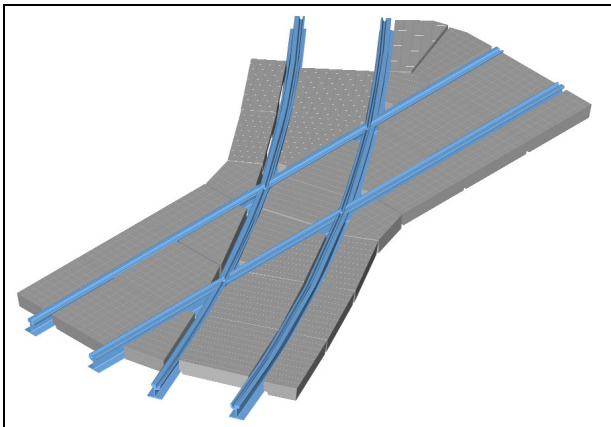
Fig.1 Survey of crossing paved by concrete plates.

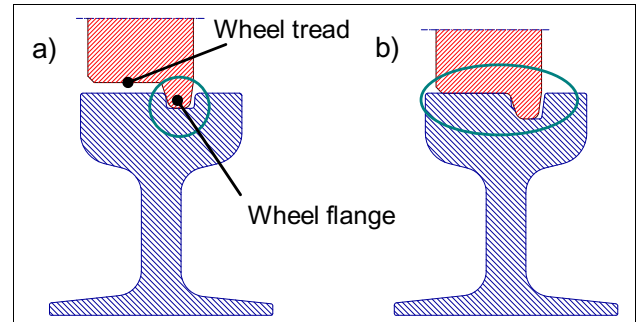
Especially, 4 to 5 years after building in of crossings and switches, it usually comes to a significant increase of noise and vibrations. The reason for that is the fact it then comes to the wearing out or the so called "shallow groove". The existence of a shallow groove in tracks executed with grooved rails is the usual manner to ensure the passing of vehicle wheels over assemblies without impact. Namely, on a part of the traffic lane crossings, vehicle wheels are driving over wheel flange outlets (Fig. 2a). After wearing out of the shallow groove, traffic lane interruptions appear, causing impacts because of passing of vehicle wheels, because the wheels are no longer driving on the wheel flange outlet but on the wheel tread, Figure 2b.

Fig.2 Wheel movement over crossings: a) new crossing; b) worn crossing

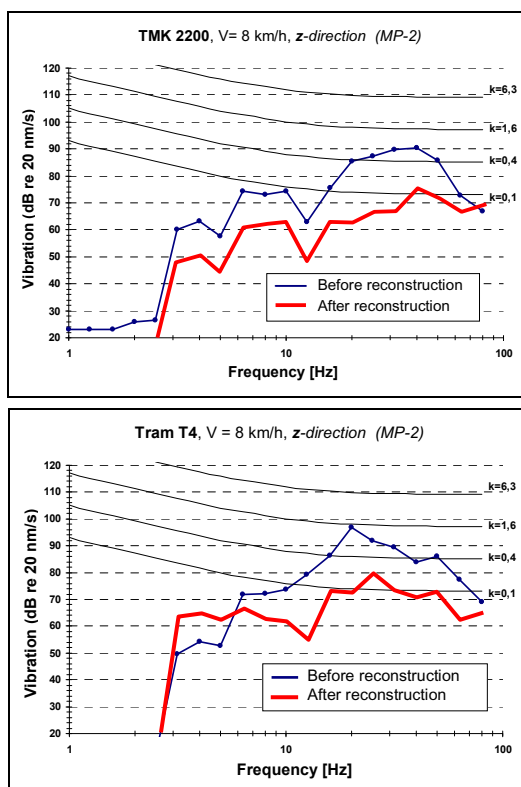
Fig.12 Ground vibrations (measurement in the field).

Analysis and comparison of vibrations in the direction of axis z within the frequency range from 1 Hz to 80 Hz at the moments of maximum measured vibrations for a single tram passing is shown in Table 1. Vibrations caused by tram traffic before reconstruction, on both measurement points, are ‘well noticeable’ ($0.4 < K \leq 1.6$). After reconstruction, base vibrations were imperceptible or on the verge of very weak vibrations, [6].

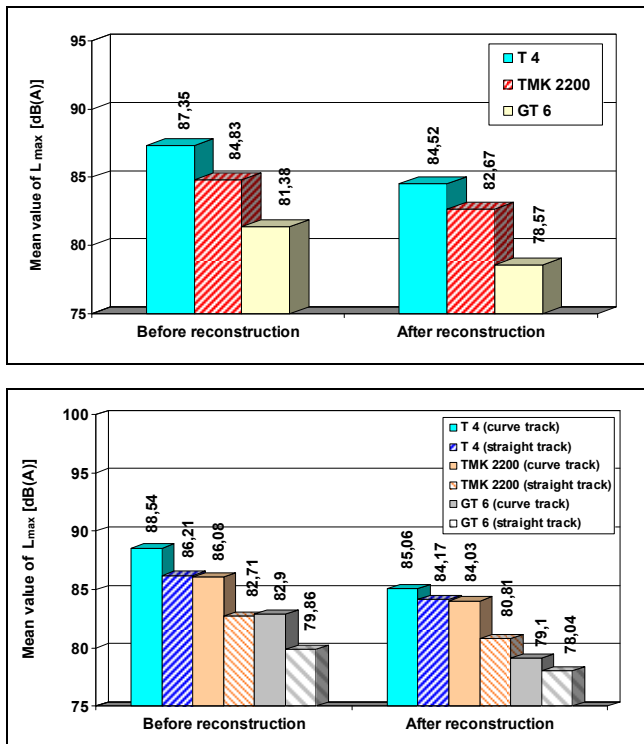
Fig.15 Mean value of maximum noise levels.

As it is visible in the picture, the medium value of the peak noise levels after reconstruction is less than 1.5 to 3 dB(A) in relation to the measurements before reconstruction (on the same measuring point). At the crossing, somewhat less noise decrease in relation to the targeted one of 5 dB(A), which was based on the previous testing on the testing range, was obtained. The reason for a smaller decrease of noise level than the expected one is in the fact that the testing on the testing range was conducted with an impact load, whereas not only the noise coming from wheel impact on the spots of track assemblies and junctions is present during tram passing on the track, but 'squeaking' during vehicle movement on the track, which is curved, [2, 6] also appears. If we observe Jurisiceva-Draskovičeva crossing, the phenomenon of 'squealing' appeared during tram movement in the direction Jurisiceva-Rackoga (direction 1), and Rackoga-Jurisiceva (direction 2), where the radius is 50 m, and especially during tram movement in the direction Jurisiceva-Draskovičeva, where the radius is 20 m (direction 3). During vehicle movement on curves with a smaller radius, lateral wear out of tracks appear, the consequence of which is a larger track width, but also a decreased squealing of the vehicle. After reconstruction, the track geometry (especially the track width) was brought to the proscribed limits, the consequence of which is the appearance of an increased squealing caused by tram movement.
