# Vibration control in a tunnel under an office rehabilitation project

Marc Asselineau<sup>1</sup>, Stéphane Mercier<sup>1</sup>

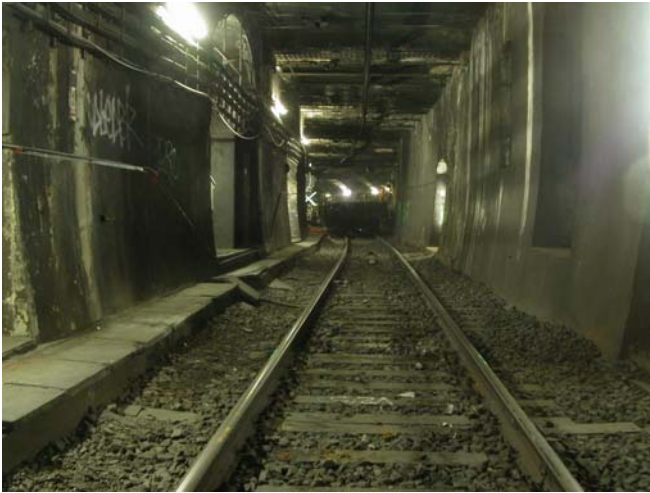
Over the years the line was modernized, with overhead replacing the third rail and more modern rolling stock taking over. However it was not possible to increase the loading gauge or to broaden the curves (Figure 1). With the opening of the rail connection between Orsay and Invalides this former branchline was eventually turned into a major part of the Paris express rail network, with a train running every 2 mn on each track at peak hour.

**Figure 1:** The tunnel before rehabilitation; note the reduced loading gauge and the structural connections of the track to the tunnel walls.

Basically, the vibration control measures called for a resilient mat under and on each side of the ballast, with careful consideration being given to the overall thickness as it could eventually foul the loading gauge. In addition, the ground floor of the building over the tunnel was rebuilt using a thick concrete slab.

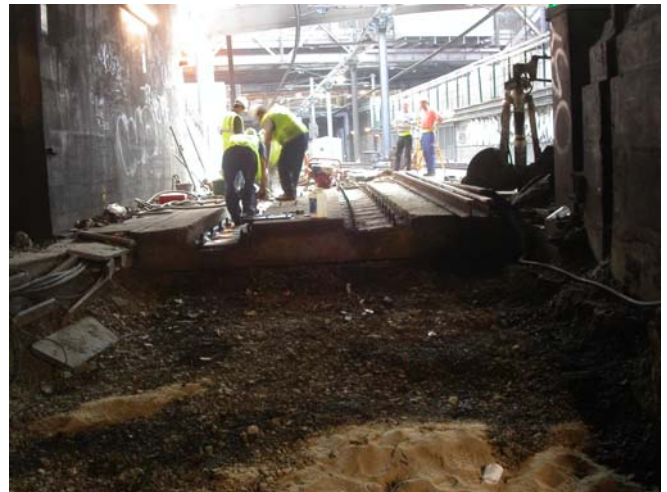
**Figure 2:** Entrance to the tunnel under the building; note the concrete structure in the background.

Right out of the tunnel by the administrative building the track was rigidly laid on a concrete structure structurally connected to the tunnel (Figure 2). It was found out that vibratory energy was transmitted from this zone too.

Meanwhile the original rail fasteners on the concrete portion out of the tunnel were removed and replaced by resilient fasteners by Pandrol. Care had of course been taken to ensure that the ballast mat from the tunnel was laid along the edge of the concrete structure so as to prevent vibration transmissions at this end.

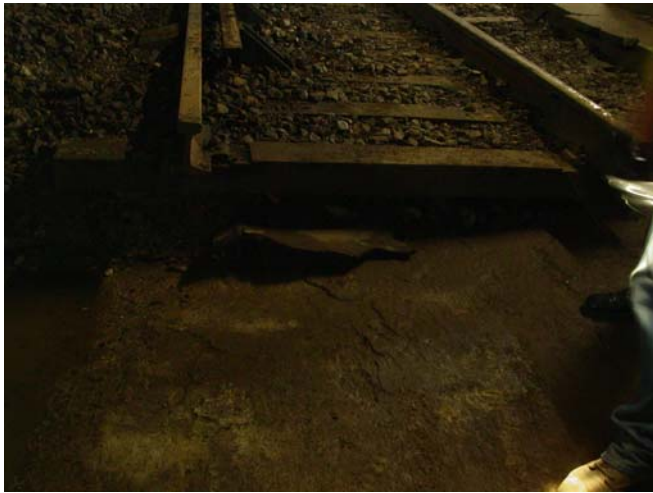
Close examination of the building lead to the discovery that the ground floor over the tunnel was rather thin. More to the point close examination of the track work showed that the ballast was rather thin; it was explained this was because of the requested height clearance for the overhead. In addition it was found out that quite a number of sleepers were abnormally long and rigidly connected to the wall structure of the tunnel, with all sleepers being broader and thicker than usual; it was explained by the track gang that due to the restricted loading gauge all those sleepers were of the type normally used under point work. More to the point the western lower tip of those sleepers was grinded away in order to accommodate the irregular ground (Figure 3). As for the rigid connections to the structure it was found out that due to the restricted clearance the track was not mechanically laid and in order to extend its operational life

structural connections were added. More to the point, it was also found out that one of the track had been treated to a resilient mat in older times, however it had been ripped to shreds by an earlier mechanical tampering of the trackwork. At any rate no trace of mat between the ballast in the tunnel and the concrete structure outside was found.

**Figure 3:** Cross section of the trackwork showing the larger than usual ties thinned on one side.

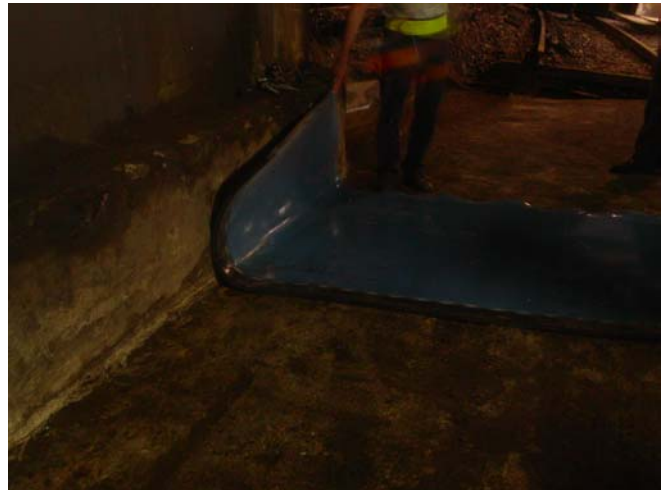
**Figure 4:** The resilient mat by Sylomer glued to the floor and lower walls of the tunnel.

Advantage was taken of a summer break in the operation of the line due to heavy track renewal further down the line. Over two shifts of two weeks, one for each track, the old track and ballast were removed, and then the ground was carefully scrapped so as to erode any protrusion. Resilient mats by Angst+Pfister (Sylomer 25B) were then glued in position (Figure 4), with particular care to ensure that the junctions between mats were tight enough to prevent the intrusion of ballast material. A first layer of ballast was then spread over the mats in order help stabilize it, and the top of the mat was then glued and protected using a metal inverted L profile. The track was then laid ; this time no rigid connections to the walls of the tunnel were allowed but in order to help stabilize the trackwork a steel paddle was added at the tip of some of the sleepers. Prior to adding more ballast, the clearance between the bottom of the paddle and the mat was carefully checked. After completion of the ballast a careful examination was performed in order to spot any zone where ballast might have been spread over the top of

the mats, with any excess carefully removed. The ballast was then manually compacted.
