*The 29th International Congress and Exhibition on Noise Control Engineering  
27-30 August 2000, Nice, FRANCE*

## **TRAFFIC ROAD VIBRATION ENVIRONMENT AND ITS PROPAGATION TO RESIDENTIAL AREA IN JAPAN**

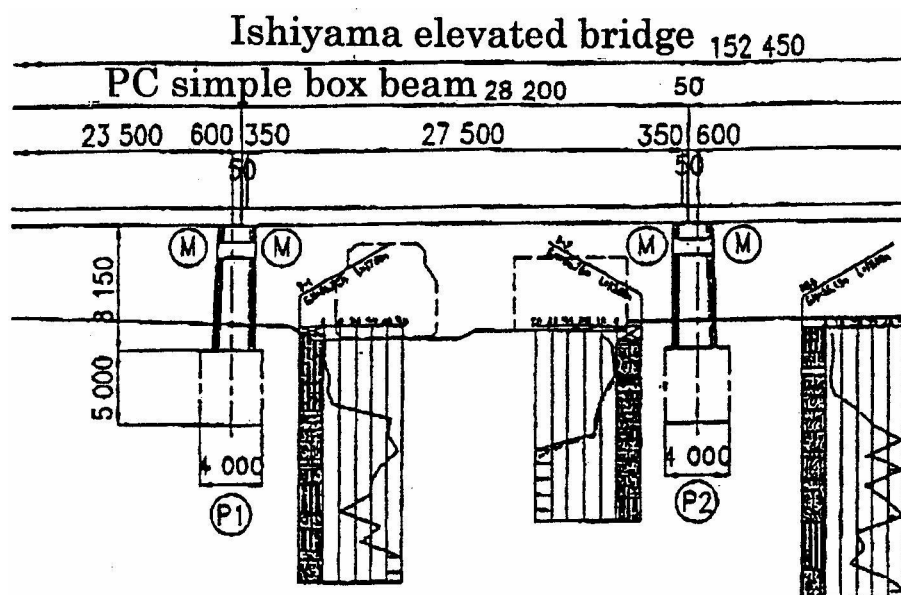
Figure 1: General view of the bridge after the work.

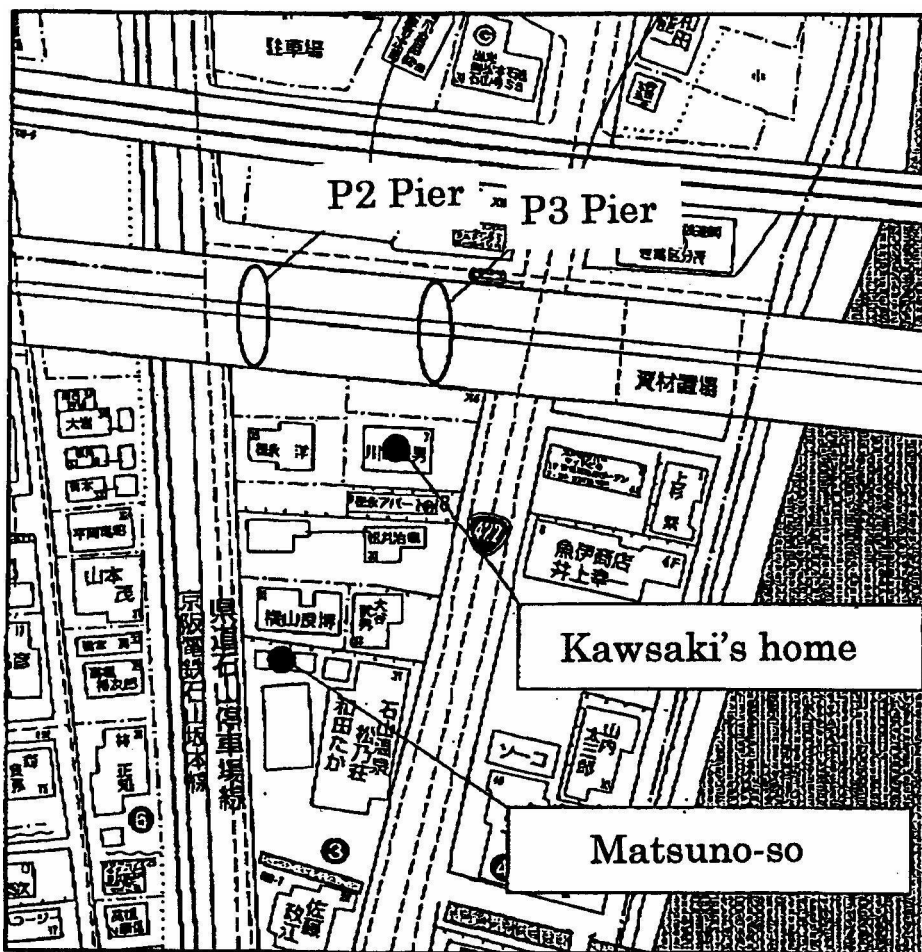
Figure 2: Plane view of the test site.

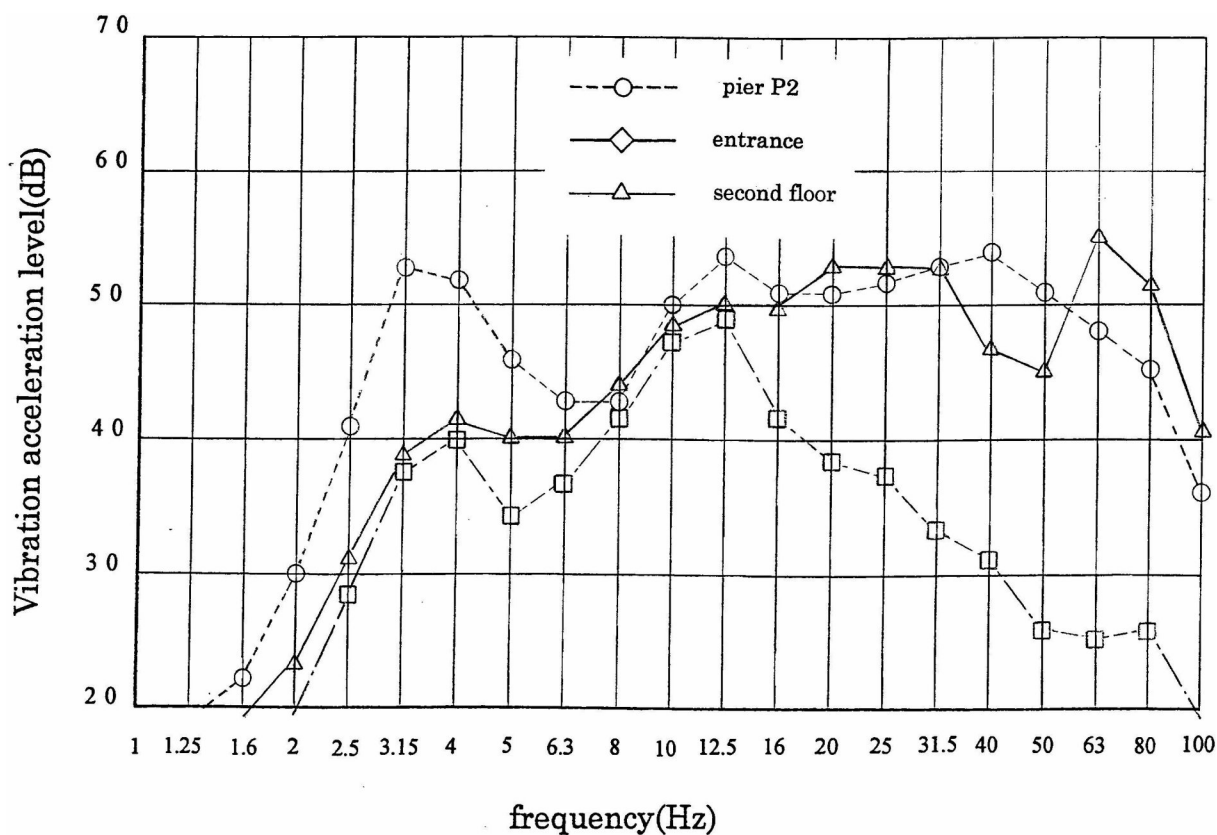
Fig. 3 shows the vibration acceleration levels recorded at three different locations at different frequencies. The vibration registered in the Japanese-style room is seen to have been predominantly in a frequency range over 20 Hz.

**Figure 3:** Result of frequency analysis (Kawasaki's home, Z direction).

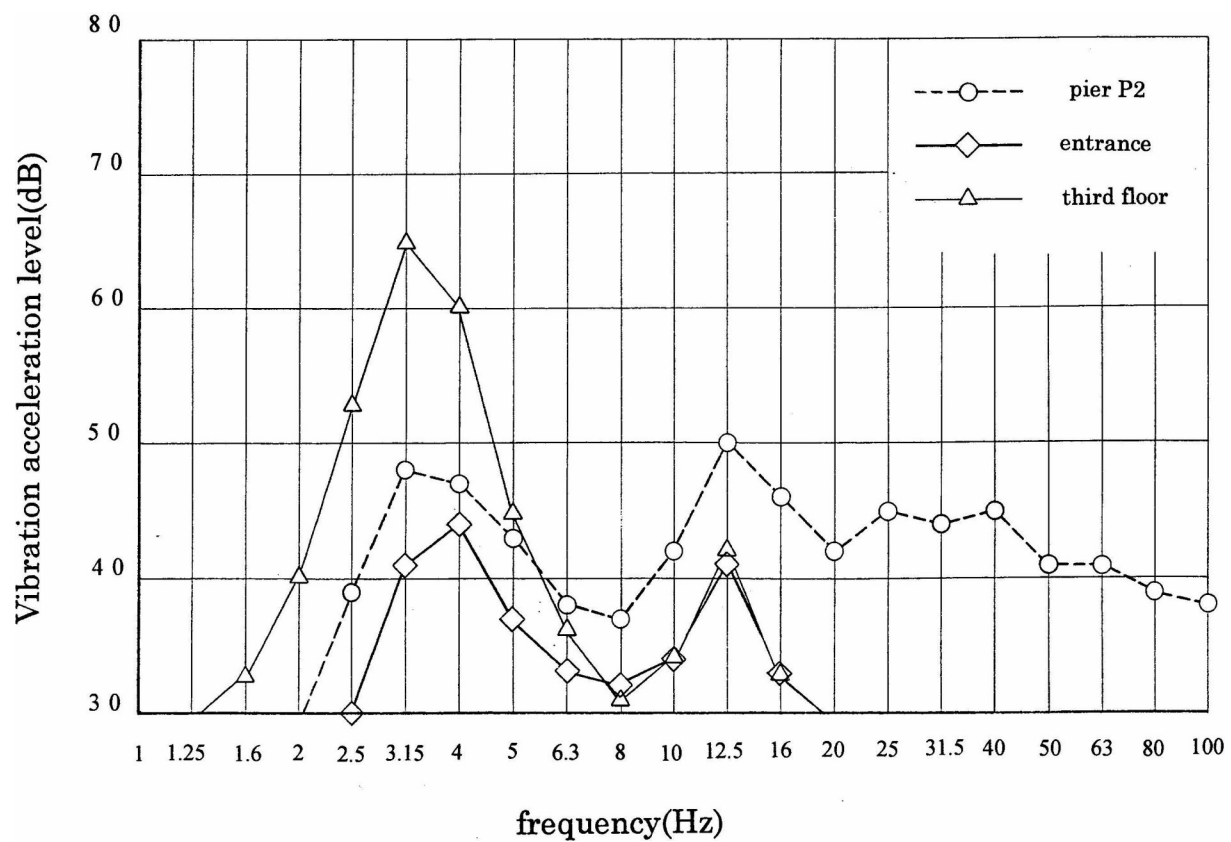
Shown in Fig. 4 are the acceleration levels over a range of frequency. Peaks are clearly seen at around 3 Hz at which the level reached as high as 60 dB in the room addressed. The highest among the five levels recorded was 67 dB, this being 2.2 cm/s<sup>2</sup> when converted in Arms value which exceeds by far the standard permissible limit (for comfortable human habitation). The frequency of vibration actually felt there, being in the order of 3 Hz, is in good agreement with the data shown in Fig. 4.

Figure 4: Result of frequency analysis (Matsuno-so, Y direction).
