# Assessment of sound transmission characteristics of traditional timber-framed dwellings in Ankara, Turkey

## Summary

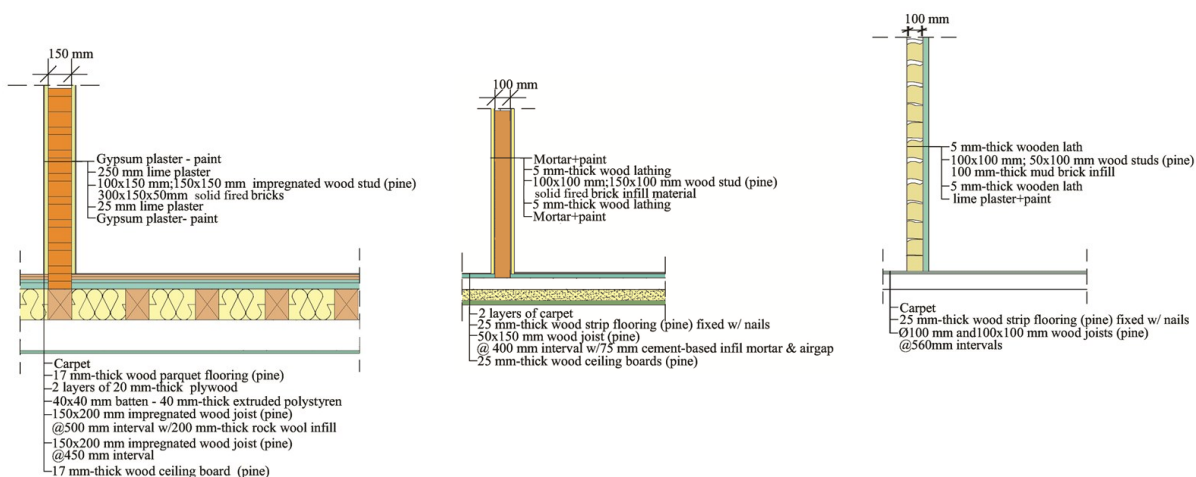
Figure 1. The configuration of existing walls and floors and definition of each layer forming the Reconstructed-Wall & Floor 1 (at the left); Semi-Repaired-Wall & Floor 2/3(at the middle); Original-Wall & Floor 4 (at the right).
