A special procedure to guarantee sound isolation in dwellings

Wilhelmus Beentjes

Lichtveld Buis & Partners, Postbus 1475, 3430 BL Nieuwegein, Netherlands
beentjes@lbp.nl

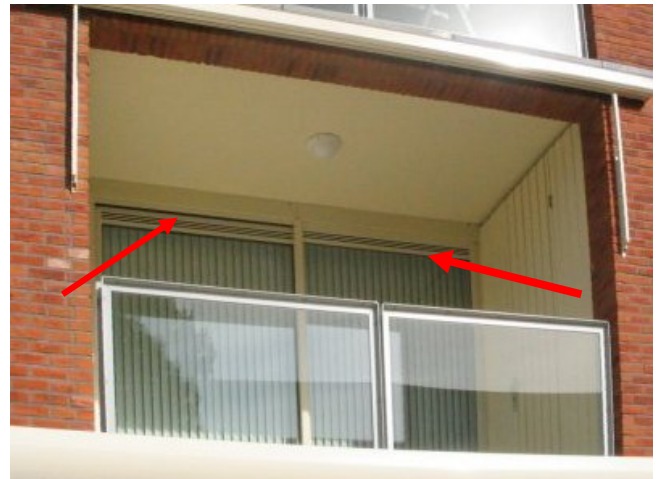
1. Too much ventilation was installed.
2. There are two facts that lead to lower sound insulation of ventilation grates
 - a) The angle of incidence
 - b) The position nearby ceilings at the inside and/or the outside (balconies, galleries, see fig. 3). Both effects are described in EN 12354 part 3 [9], and till a few years ago the corrections for both effects were only used for ventilation mufflers. The investigation showed that the agreement between measurement and calculation improves significantly when both corrections were used also for ventilation grates.
3. In situations with small facade-areas and a large volume of the receiving rooms (and a relatively high ventilation) the acoustical quality of the ventilation grate must be higher than the mostly needed $R_{qA} \geq -2$ dB according to Eq.[1]. See also list of used symbols.

Fig 3 Ventilation grate near a ceiling outside

1. According to the prescriptions of the manufacturer reducing the opening of the ventilation grate or muffler to the required value;
2. Increasing the R_{qA} -value by another ventilation grate with a higher R_{qA} or by placing more absorbing material in the ventilation grates;
3. See 2.

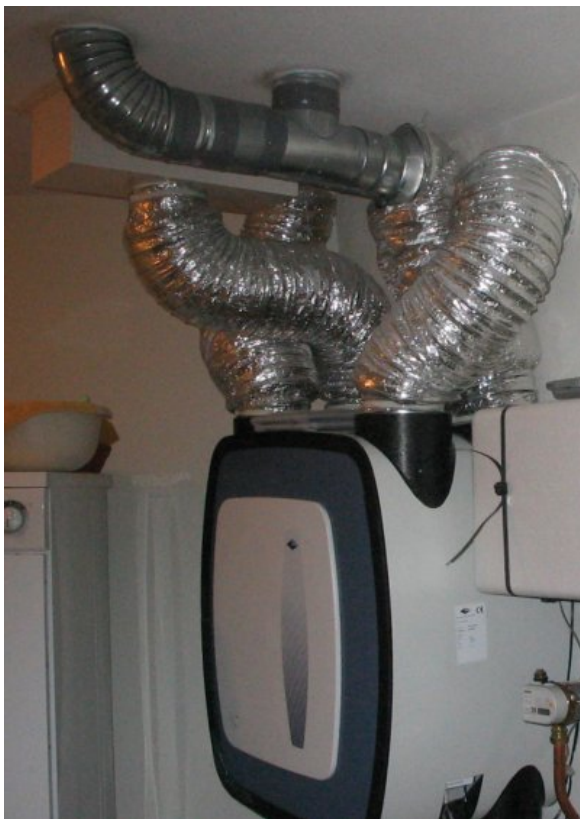
1. The equipment is not installed regularly
2. The ventilation box is placed against a wall with a mass less than 200 kg/m²
3. In the ducts the length of the acoustical duct is too short, see fig. 2
4. There is too less room for installing acoustical ducts, see fig. 2.

Fig. 2 Balanced ventilation unit with too short acoustical ducts and also with bends with too much resistance, which result in too much noise. L_{IA} varies from 34 to 52 dB.

1. Installing the system correctly;
2. The systems can be placed against concrete ceilings, or can be placed on tables or heavy walls with a mass more than 200 kg/m²;
3. Making more room in vertical or horizontal direction for more ducts
4. Change the position in the floor or ceiling where the acoustical duct meets the ducts

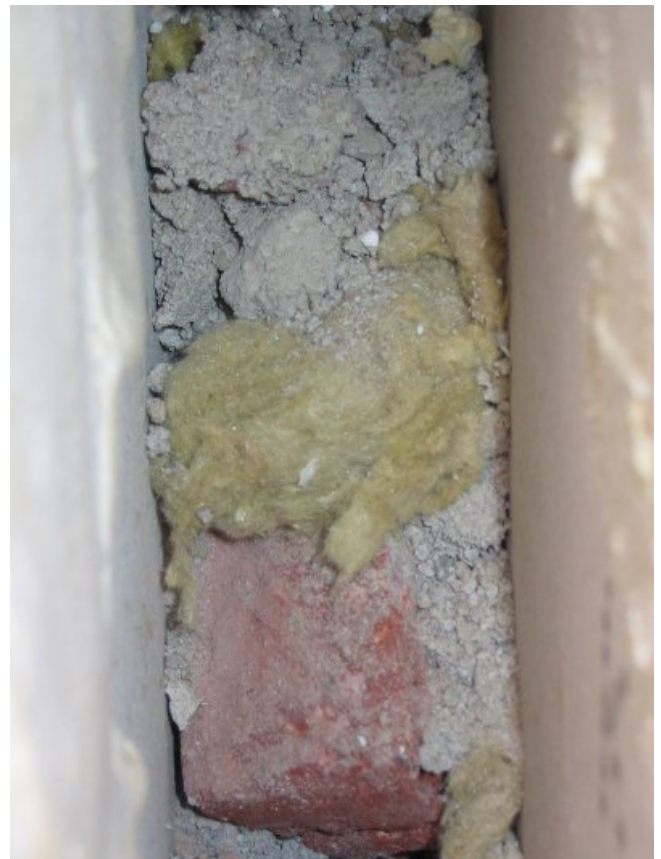
1. Airborne sound insulation between common areas in apartment buildings and living and sleeping rooms. Mostly the sound insulation of the entrance door has insufficient sealing of gaps or there is only an entrance door between the common area and the rooms.
2. The partition wall has too low a mass.
3. Sometimes the mass of a flanking part is too low or the junction with the partition construction is too rigid
4. Junction between the partition wall or floor with a window-frame leaks;
5. The cavity in a cavity wall of stone-construction is partly filled with (pieces of) concrete or other types of pollution. See fig. 4

Fig. 4 The cavity of a cavity wall is near the ground floor no more a cavity. By cleaning the cavity the airborne sound insulation was improved from $R_A = 46$ to 59 dB.

2. Placing an acoustical lining in front of the partition wall, which give sometimes problems with reducing the room area and financial compensation.
3. If possible make the junction flexible or if this is not possible, place an acoustical lining. In case of light roof elements fit an extra heavy plasterboard panel against the roof element.
4. Close the junction with a sealant.
5. Cleaning the cavity via the facade with the aid of specialised concrete firms with special saws or long drills.
