**Acoustics'08
Paris**
June 29-July 4, 2008

Don't forget the quench pipe when installing an MRI

Carel Ostendorf

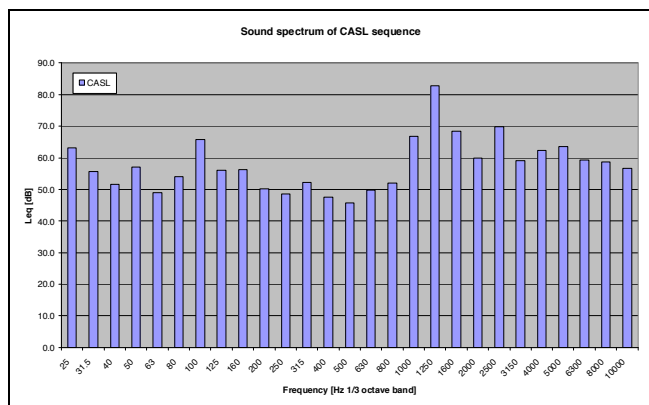
Fig. 2 sound spectrum in 1/3 octave band of CASL sequence

Figure 2 shows that the 1250 Hz is very prominent in the sound spectrum. Therefore in figure 3 the profile of the 1250 Hz band is given.

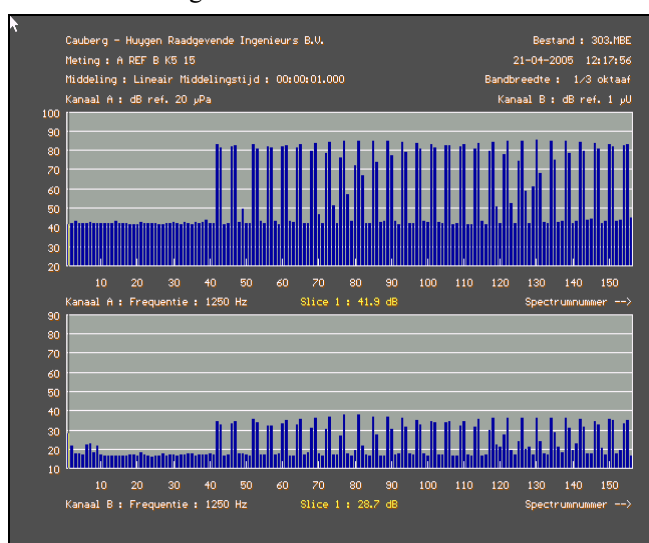
Fig. 3 Profile of 1250 Hz sound level near MRI (top graph) and in office above MRI (bottom graph).

Now it is clear why the noise of the CASL sequence can be heard so clearly. The difference between background level and CASL sound level is about 12 to 18 dB in the office.

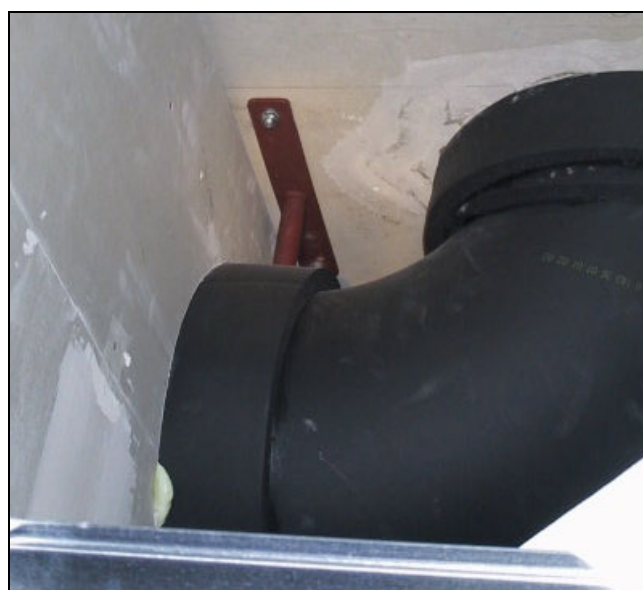
From this situation it was clear that airborne noise was a factor in the noise problem. Construction noise could be involved as well because the quench pipe inside the building was attached to the building construction which was in this case the floor of the office. Figure 5 shows this in detail.

Fig. 5 Construction detail of quench pipe connected to the building.

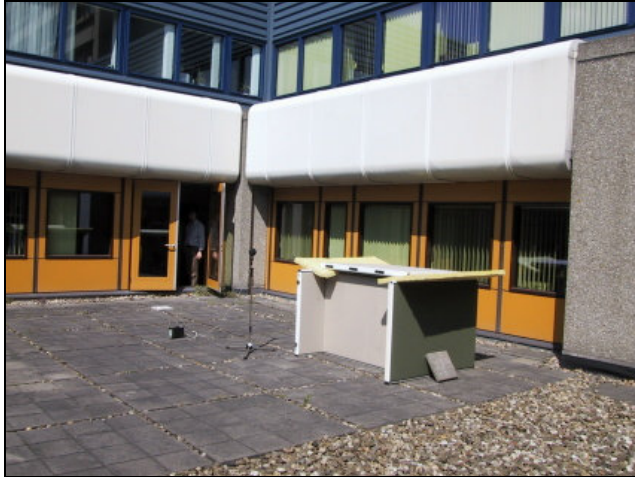
The sound reduction of the quench pipe was achieved by placing an enclosure around the quench pipe. The enclosure was made of sound absorbing panels which happened to be stored in the hospital because they were not used at that time. Since the quench pipe is a safety device, it was not allowed to build a rigid construction. If an explosion would occur during the sound test, the sound enclosure had to be easily blown away. So the panels were just placed against each other and gaps were closed with extra sound absorbing material. Figure 6 shows the result.

Fig. 6 Sound enclosure quench pipe.

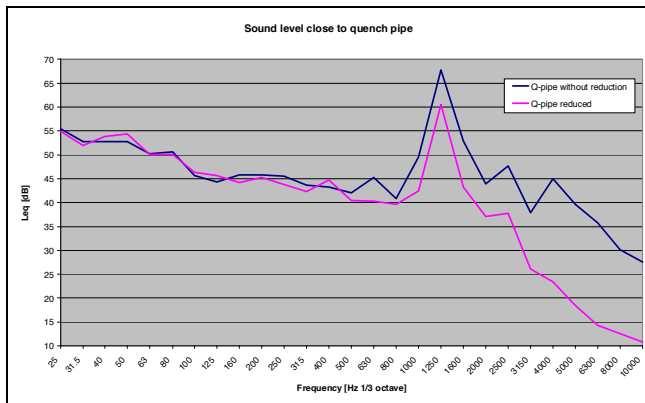
Before and after the enclosure was placed, a sound measurement was done at approximately 1 meter distance of the quench pipe. The result of the measurement with and without enclosure is shown in figure 7.

Fig. 7 Sound spectrum of quench pipe (distance 1 m) with and without reducing enclosure.

Figure 7 shows the relevance of the 1250 Hz band. The temporary enclosure has achieved a reduction of 7 dB in this frequency band. If only airborne noise is the cause of the problem, the sound level in the office will be reduced with 7 dB as well for the 1250 Hz band. If the reduction is less, construction noise has an influence.

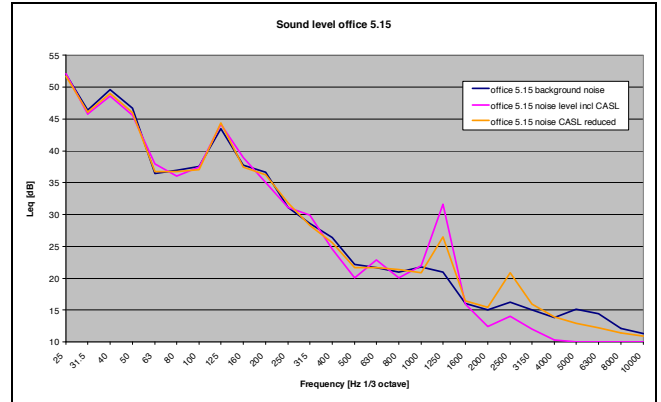
In figure 8 the result is given for the influence of the enclosure on the sound level in the office. Three lines are shown in the graph: the background level if the CASL sequence is not active, the sound level with active CASL and the sound level with enclosure around the quench pipe.

Fig. 8 Sound level in the office with and without enclosure.

Without the enclosure, the sound level of 1250 Hz is an averaged 10 dB over the background level in the office. With the enclosure the sound level of the CASL sequence is reduced by 5 dB. This is not as much as the reduction close to the quench pipe. This means that construction noise has some influence but that airborne noise is the most important factor. So, the first measure is to reduce the noise of the quench pipe. If after those measures the noise of the CASL sequence is still a nuisance, then measures to reduce the influence of constructing noise have to be taken.

The MRI technicians of the hospital were able to change the setup of the CASL sequence thus producing fewer specific tones and less noise.
