# Comparison of different approaches in characterization of impact defects of composite plates

J. Liu and N. F. Declercq

Composite plate materials are widely used in almost all branches of modern industries and everyday life. Characterization of impact defects of these composite plates is of great interest in the quality control and safety monitoring. A variety of nondestructive methods are available for this purpose; immersion (water-coupled) ultrasonic testing is one of them and is known for its high reliability and efficiency. In this paper, several immersion ultrasonic approaches are compared for their application to characterize impact damage of carbon/epoxy plates. Two sample plates with damage caused by controlled impact are tested. Three testing configurations are discussed and several time-domain and frequency-domain data processing methods are applied. The comparison of the results shows that with an optimized combination of testing configuration, transducer and frequency selection and data processing methods, the defects can be more accurately and easily characterized than conventional ways.

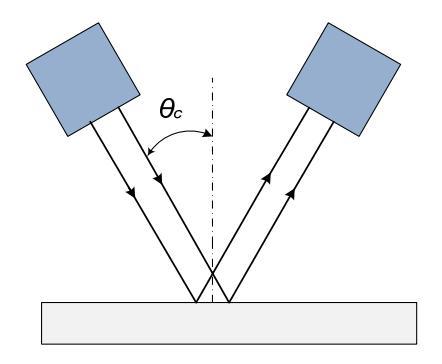
Figure 1: Schematic of pseudo pulse-echo mode at the critical angle  $\theta_c$ .

In this work three experimental configurations are applied for C-scans on an area of 40 mm x30 mm covering the impacted positions: pitch-catch or transmission-through mode, pulse-echo mode and pseudo pulse-echo mode (Figure 1). As the most widely used modes for ultrasound testing, pitch-catch and pulse-echo modes are chosen due to the convenience of operation and their wide validity in other testing.

A third mode called pseudo pulse-echo mode is also chosen for the purpose of comparison. The schematic of this mode is shown in Figure 1. In the pseudo pulse-echo mode two transducers, the emitter and the receiver, are set at an angular position where the angle between their normal direction and the normal direction of the sample surface is a critical angle. The critical angles of the sample plates are measured in a polar scan shown in Figure 2. In this work, the second critical angle ( $\theta_c$ =30°) is used instead of the first one ( $\theta_c$ =9°) because of the convenience of operation.

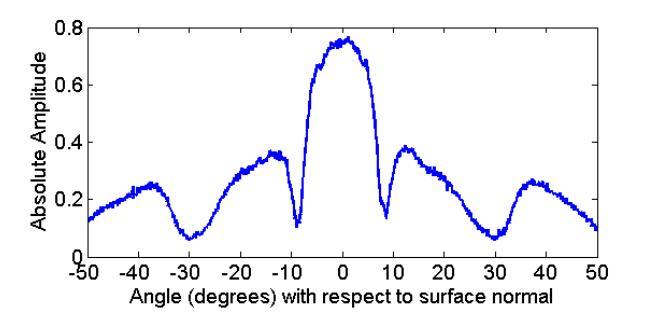
Figure 2: Absolute amplitude of transmitted wave through the sample plates at different indent angles.

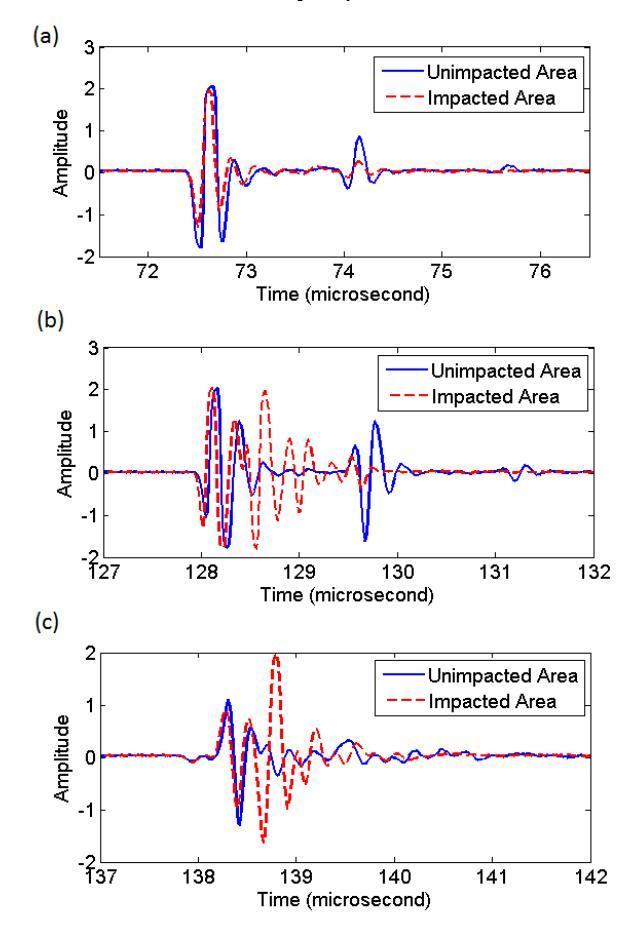
Figure 3: Comparison of response signals at unimpacted area and impacted area for (a) pitch-catch mode, (b) pulseecho mode and (c) pseudo pulse-echo mode.

The time-domain response signals obtained at both unimpacted area and impacted area in three modes are shown in Figure 3. It can be observed that at the unimpacted area three response waves are detected for pitch-catch mode and pulse-echo mode and two detected for pseudo pulse-echo mode. This is logical results based on the fact that composite plates have small thicknesses. This characteristic makes it possible to extract more information concerning the inner defects by analyzing the second and even the third response signals because they go through the plates more times than the first one and accordingly contain more information about the inner structures.

It can also be observed that for both pulse-echo and pseudo pulse-echo modes, the interval between the first response wave and the second one experiences more changes than other time ranges. This fact can also be used in data processing for the purpose of obtaining effects of inner destruction caused by impact.

As noticed in Figure 3 in pitch-catch mode there are three waves in time-domain after going through the plates. Their amplitudes are different due to the attenuation they experience in the process of traveling within the plate: the first wave goes through the whole thickness once, the second one three times and the third one five times. It is logical that the more times a wave going through the plates, the more attenuation they get and the more information they carry about the inner structures of the plates. However, the more attenuated the waves are, the smaller the ratio of signal to noise are and this makes the third wave less sensitive to the inner structural defects.

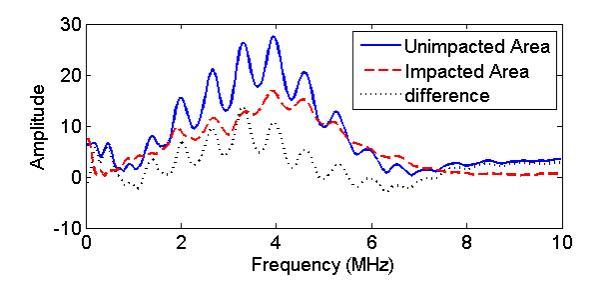
Figure 4: Comparison of the spectrums of response signals at unimpacted area and impacted area for pitch-catch mode.

Figure 4 shows the comparison of frequency responses between a wave obtained from unimpacted area and one from the impacted area in pitch-catch mode. It can be observed that due to the limited thickness, oscillating components appearing at a period of around 0.66 MHz in the spectrum of a signal obtained from unimpacted area are not obvious in the spectrum of the signal obtained from impacted area. This leads to a relatively large difference in amplitude at those frequencies and they are used in this work to evaluate the effects of damaged inner structure. In addition, the same phenomenon can be observed in pulseecho mode.

frequencies chosen here are those corresponding to the peaks in Figure 4. The interesting thing is that they all confirm the position of the defects, but the damage level (indicated by color) of the defect relative to the neighborhood areas are different. This is reasonable because at different depth, the damage levels are different.

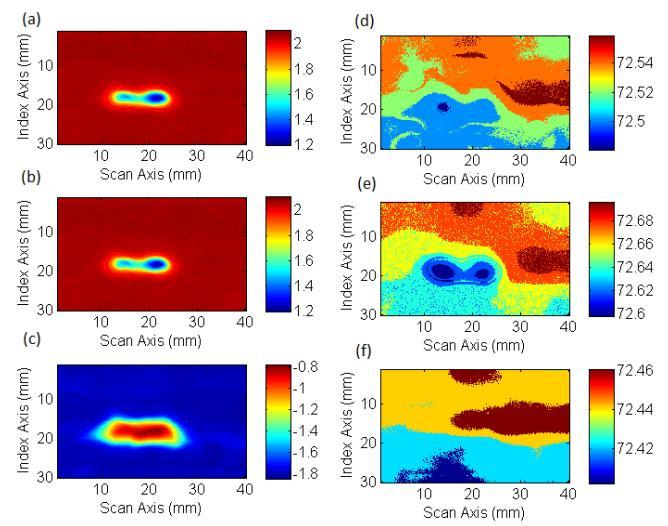
Figure 5: Comparison of the effects of amplitude and TOF in characterizing the impact defect for Sample 1. (a), (b) and (c) are respectively the amplitudes of absolute values, maximum peaks and negative peaks of the first response wave at each position; (d), (e) and (f) are respectively the

TOFs to negative peaks, positive peaks and preset threshold.

In order to compare the feasibility of the most commonly used wave characteristics, TOF and amplitude, in characterizing the impact defect inside the sample plates, both amplitudes and TOFs in a 40mmX30mm C-scan are shown in Figure 5. It can be easily observed that amplitude is much more sensitive to the inner impact damage of the sample composite plates than TOF. This is probably due to the fact that the thicknesses of the samples are small and so there is no enough length for sound speed change being detected and clearly visualized in the form of C-Scan. The reason that amplitude has strong sensitivity to impact defects is probably that the inner structures of the damaged area are irregular and this causes more energy loss by sound diffraction.

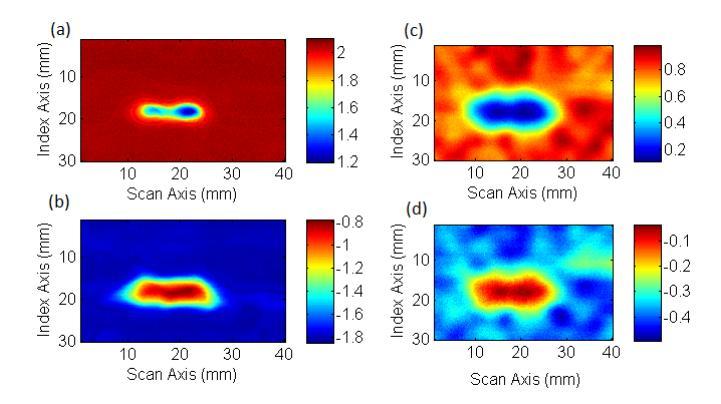
Figure 6: Comparison of the amplitude sensitivity to impact defects of the first wave and the second wave in pitch-catch mode. (a) and (b) are respectively the amplitudes of the maximum peaks and minimum peaks of the first wave; while (c) and (d) are those of the second waves.

The difference stated above can be observed in Figure 6 through comparison of the amplitudes of the maximum peaks and minimum peaks of the first wave and the second wave obtained in pitch-catch mode. The defect areas obtained from the second wave is much larger than those obtained from the first wave. This does not mean that one of them is less accurate and less reliable in characterizing the inner defects, but they carry the information of the same defects at different levels. Obviously, the results obtained from the second wave tell us more.

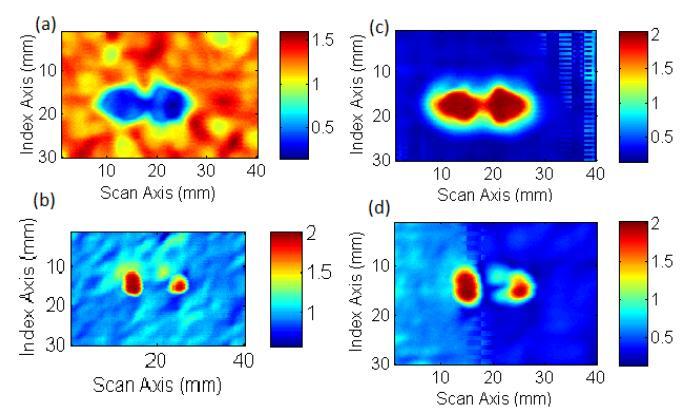
Figure 7: Comparison of the amplitude sensitivity to impact defects of the signal in the interval between the first two waves in (a) pulse-echo mode and (d) pseudo pulse-echo mode and the second wave in (a) pulse-echo mode and the first wave in (b) pseudo pulse-echo mode.

For pitch-catch mode the first wave carries enough information to characterize the defects because it goes through the plate once, but for pulse-echo mode and pseudo pulse-echo mode the first wave is mainly specular reflection from the plate surface and therefore not sensitive to the inner defects. For these two cases the signals in the interval between the first and the second waves are more sensitive to the defect because they are mainly the reflection from the inner defects in the plates before the sound reaches the bottom surfaces of the plates. The maximum amplitudes of the signals in the intervals are compared with those obtained from the second wave in pulse-echo mode and the whole waves in the pseudo pulseecho mode in Figure 7. It can be seen that the interval signals give clear image about the shape of the defects.

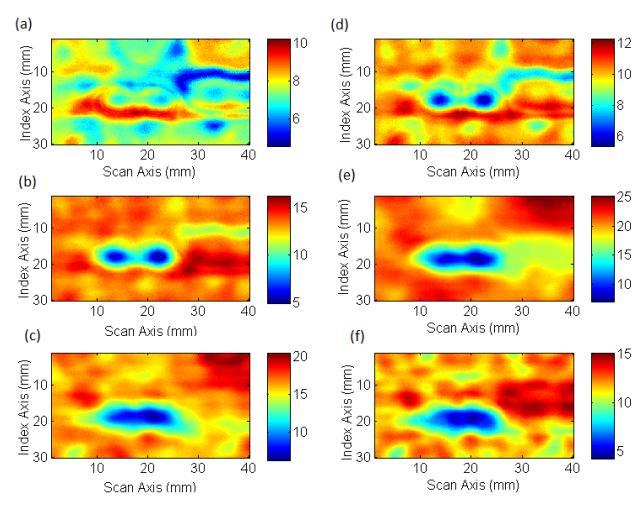
Figure 8: Comparison of the responses of maximum amplitude to the impact defects in pitch-catch mode at different frequency components: (a) 1.98 MHz, (b) 2.67 MHz, (c) 3.30 MHz, (d) 3.93 MHz, (e) 4.58 MHz and (f) 5.25 MHz.

In Figure 8 the attenuation of sound at six different frequencies are shown in the form of spatial C-scan. The

For all the three modes tried in this study, frequencydomain analysis works well as shown in Figure 8.
