Pop venues in living areas

Ir. Maarten Luykx MSc

Peutz Consultants, Mook, Netherlands, www.peutz.eu

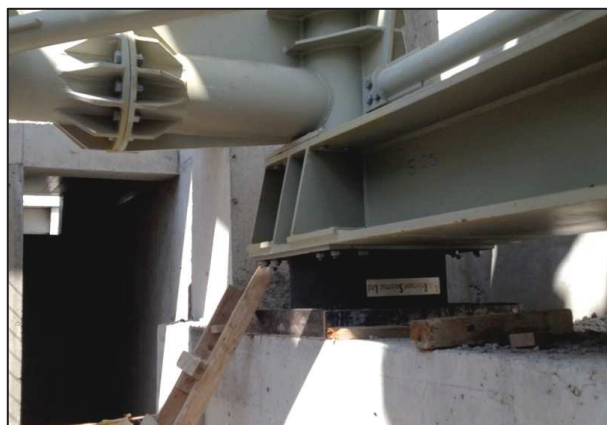
In figure 3 gives a view of one damper placed in position under the steel structure during the construction phase.

Figure 3. View of a rubber damper of $900 \times 900 \times 300 \text{ mm}$ under the roof structure.

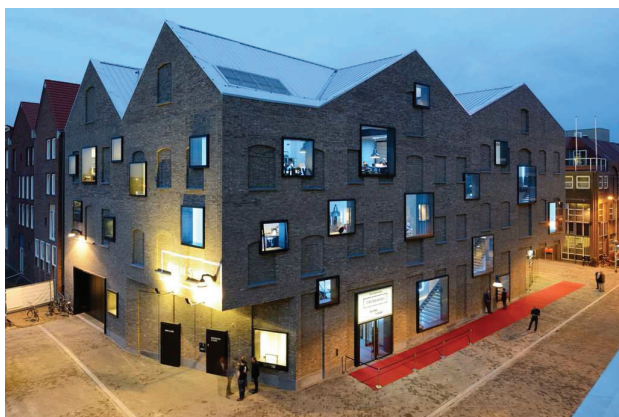
Figure 9. Exterior of pop venue Venlo (NL).

To fulfil the legal demands towards the nearby dwellings @2m from the façade with an interior music level of 103 dB(A) house, sound insulations of $R'_{A,house} \geq 61$ dB for the roof and $R'_{A,house} \geq 76$ dB for the façade were required. To realize these values a complete box-in-box structure for the pop hall was implemented with a self supporting inner box. The floor of the hall consists of a 150 mm concrete floor on 100 mm air cavity with elastic bearings on 350 mm concrete structural floor. The walls of the hall consist of a fully separated 1,300 kg/m² cavity wall of 250 mm concrete (inner box) on 200 mm air cavity with 100 mm mineral wool and a 300 mm concrete (outer box). The floor of the corridor towards the dwellings it flexibly mounted on the outer wall of the hall. Together with a width of 1,3 m of the corridor and a 600 kg/m² outside façade of the corridor, this delivers the required insulation of for the façade. The roof of the hall consists of a fully separately suspended ceiling of the inner box of 40 kg/m² gypsum boards on an air cavity of 0.5 m with 100 mm mineral wool, and a heavy outer roof of 800 kg/m² concrete. Figure 9 gives a view of the outside of the building, and figure 10 a view inside the hall.

Delivery measurements showed that all acoustic dilatations and elastic bearings function optimally. Internal sound insulations towards the rehearsal rooms and studio of $D'_{A, \text{pop}} \geq 85$ dB were measured and an external sound insulation of the roof of at least $R'_{A, \text{house}} \geq 58$ dB. Higher sound isolation values of the roof or façade could not be measured due to limitations of the measuring equipment and the masking noise outside (signal/noise-ratio). The new venue is in full use since its opening and proved to be very successful.

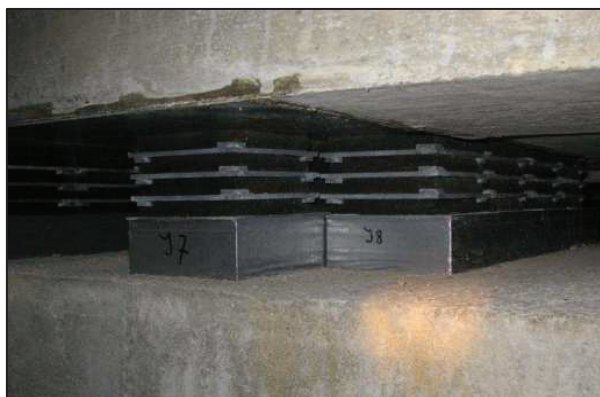
To realize a sufficient sound insulation towards the dwellings and to reduce railway vibrations an additional measure was taken by placing the total building of the dwellings on elastic bearings on the pop centre with a full dilatation in between, and by placing the dwellings aside from the pop halls. Figure 14 shows a photo of elastic bearings under the dwellings. The elastic bearings have a 10 Hz resonance frequency and a 16 MPa vertical loading capacity and consist of 4 layers of 20 mm rubber with 5 mm steel plates (size $125 \times 125 \times 95 \text{ mm}$).

Figure 14. Elastic bearings in position under dwellings on the pop centre during the construction phase.

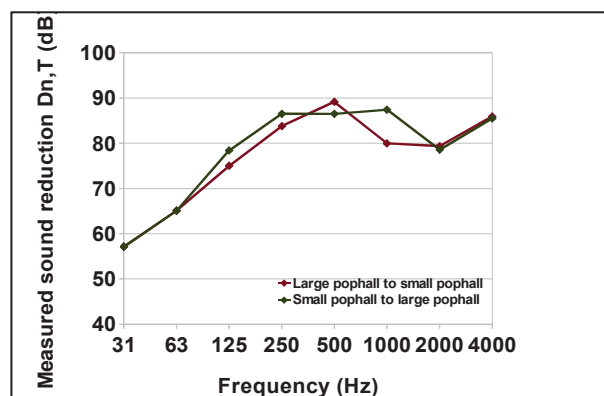
The most relevant sound insulations measured are:
 $D'_{n,T,A,house} = 99-108 \text{ dB}$ from pop hall to dwellings,
 $D'_{n,T,A,house} = 76-77 \text{ dB}$ between both pop halls,
 $R'_{A,house} = 76-79 \text{ dB}$ for the roof of the pop halls,
 $D'_{n,T,A,house} = 65-68 \text{ dB}$ from pophalls to the foyers.
 Figure 16 to 19 show measured insulation spectra.

Figure 17. Measured $D_{n,T}$ between pop halls.

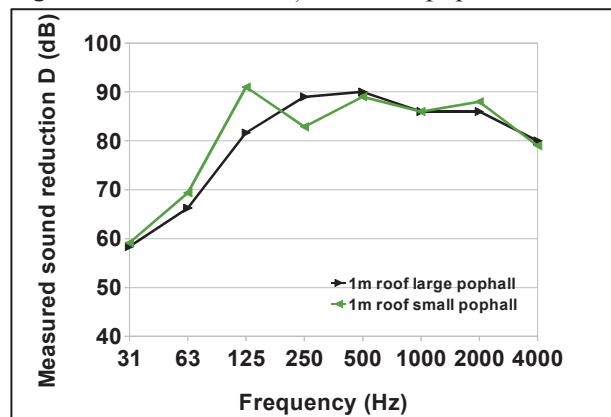
Figure 18. Measured D_{1m} of pop hall roof.

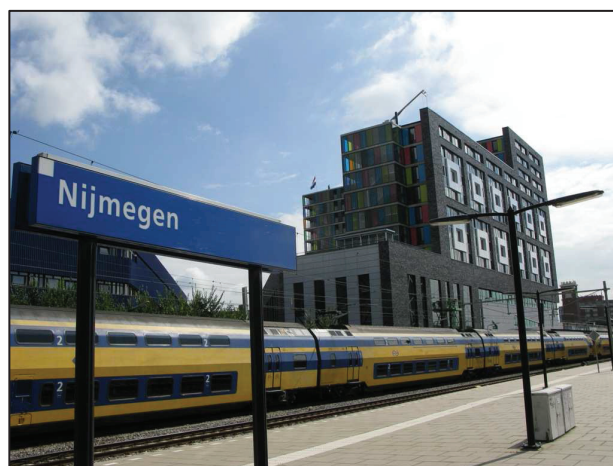
Figure 20. View towards pop centre Doornroosje and Talia-housing above it from the North-West.

Figure 20 shows a view towards the building seen from a platform of the adjacent train station.

The delivery measurements of the sound insulations showed that the high sound insulation values aimed for have all been reached and even exceeded. The projected music levels during pop concerts of $L_{Aeq}=105$ dB(A) house can therefore be easily accommodated without any disturbance of people in the apartments above the pop centre.
