# **Acoustic Effect of Drainage Gaps in Noise Barriers**

Fons Peeters M+P consulting engineers, Vught, Netherlands. Willem-Jan van Vliet Rijkswaterstaat GPO, Delft, Netherlands.

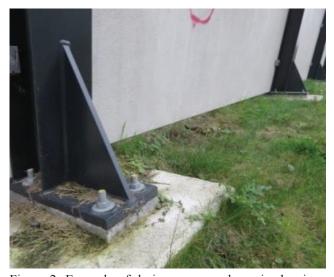
Figure 2. Example of drainage gap under noise barrier (A2 Nieuwegein)

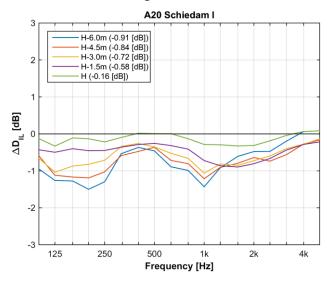
Figure 4. Example of measured effect on insertion loss, location A20 Schiedam I

The effect on the insertion loss is calculated in third octave bands and on the overall levels. A typical result of this analysis is shown in figure 4. The main results for the results on all the locations are the following:

The locations with a so called 'sharp' drainage gap show a limited effect of closing the drainage gap. On overall level the effect is max. 0.7 dB. Looking at the spectral results there are some larger effects, but not in the relevant frequency bands;

- The location with the biggest drainage gap (A20 Schiedam) shows the largest effect. The maximum effect is approximately 1.0 dB on overall level.
- The location with the smaller gaps (and partially grown) show no significant effects.
- The biggest effect occurs on the measurement positions close to the drainage gaps. At higher positions the effect is not significant.

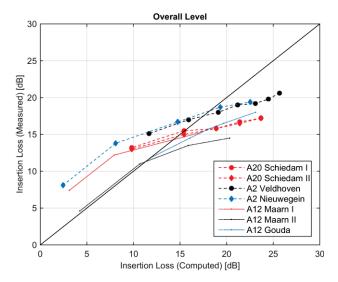
Figure 5. Insertion loss, measured vs. computed

To check the accuracy of the measurements a check of the results with computed insertion loss values has been performed. According to the Dutch standard calculation method for traffic noise (SRM2) models of the measurement positions are made. On the measurement position the expected sound levels were calculated, and the expected insertion loss on these positions were derived. As a result, it became possible to compare the measured insertion loss with the computed insertion losses. The results are shown in figure 5.

From this figure it can be concluded that for the positions with a high insertion loss (low positions behind high barriers) the measured insertion loss is lower than expected. On the other hand, for positions with low insertion losses (high positions, low barriers) the measured insertion loss is more than expected.

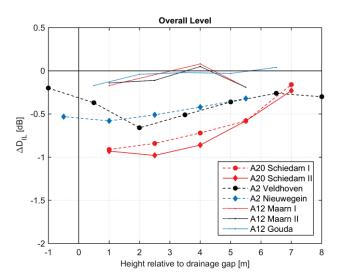
Figure 6. Effect on insertion loss vs.measurement position (and gap size).

The largest effects on the insertion loss occur at the lower measurement positions (figure 6). That means: close to the drainage gap. On higher positions the effect becomes non-significant. In some cases a result is shown for positions 'below' the drainage gap. In these cases the barrier is placed on top of a slope. These ground slopes may block the sound from the drainage gap to these measurement positions. From this figure the influence of gap size becomes also clear. The noise barriers with the biggest drainage gap show the biggest effect on insertion loss. The locations with relatively small, or partially grown gaps, show no significant effects.
